“X-33 Tank Failure During Autoclave Fabrication”

Dr. Alan T. Nettles
NASA – Marshall Space Flight Center
ED34
M.S.F.C., AL 35812

October 2, 2001

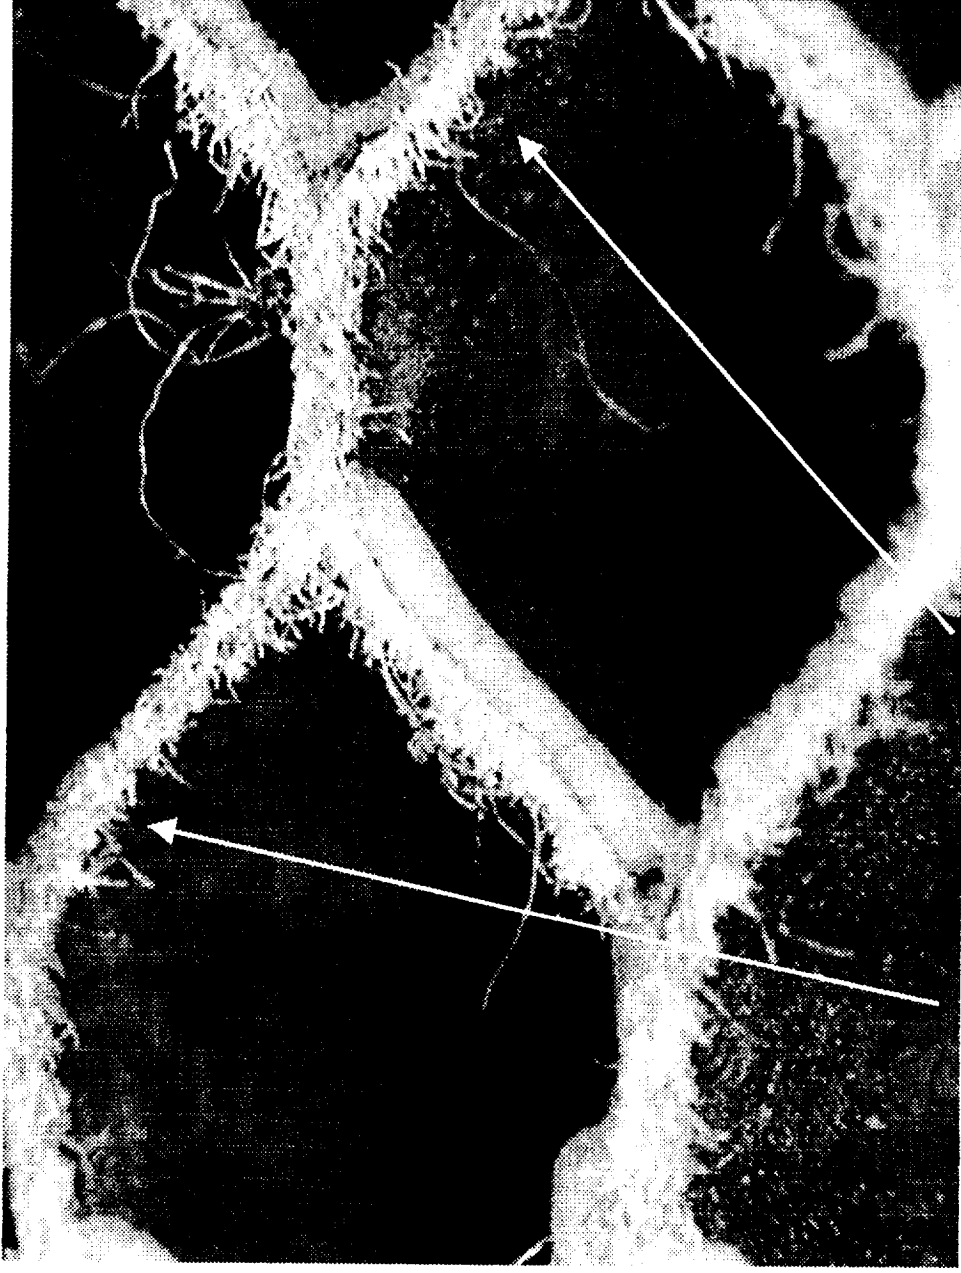
Note Lack of Fillets into Cells

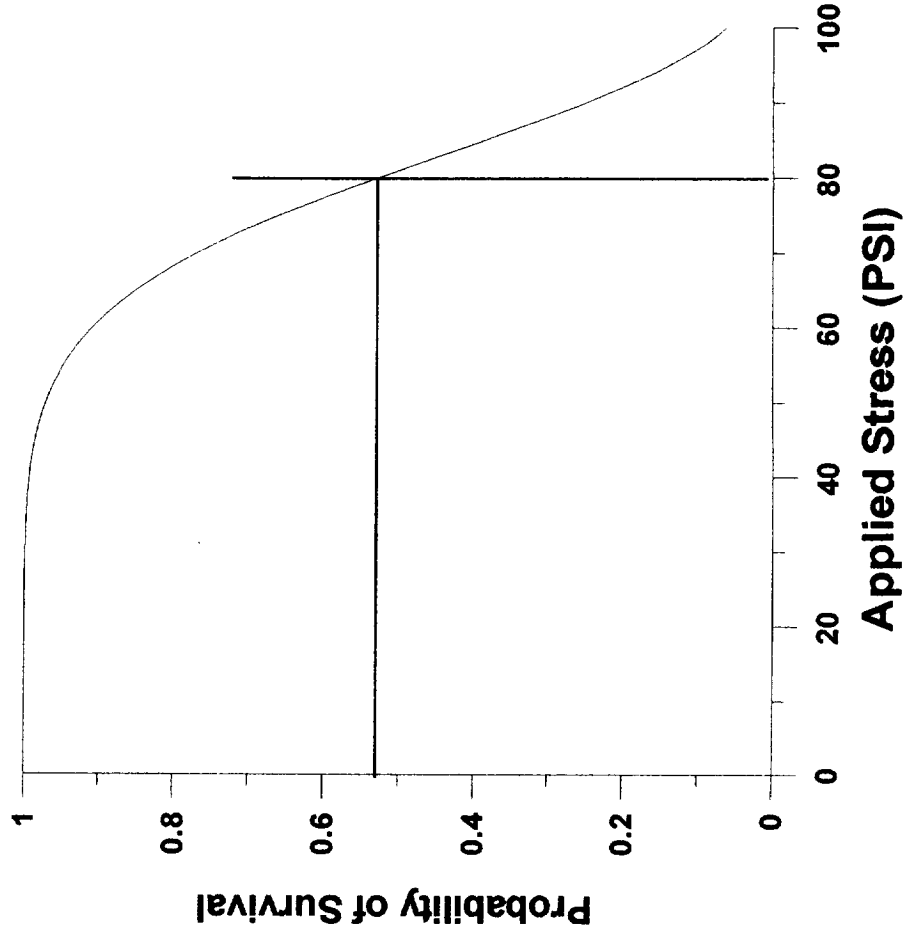
In order to have a Statistically meaningful Weibull analysis, many tests must be performed (usually at least 20). 20 data points existed for RT Testing after 50 cycles of LH2
